Regarding: Reserve Study Final Version

Level 1, Premium Reserve Analysis

Oak Meadows Owners Association, Inc.  
Road 13 & Oak Meadows Blvd.  
Firestone, CO. 80504

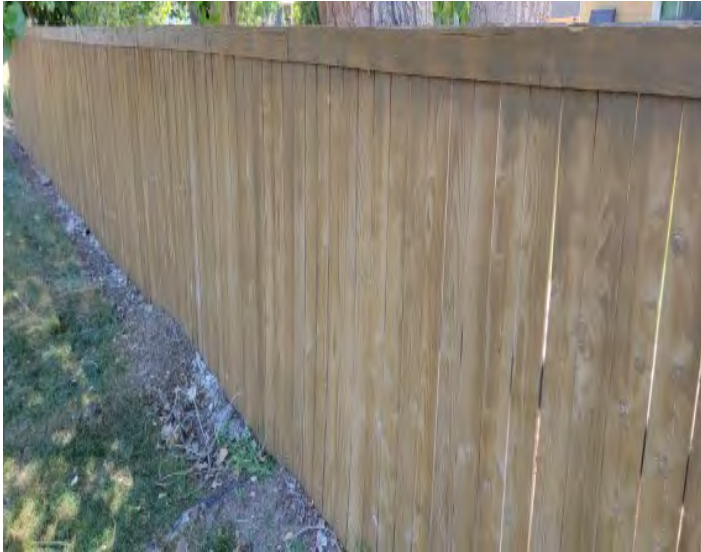
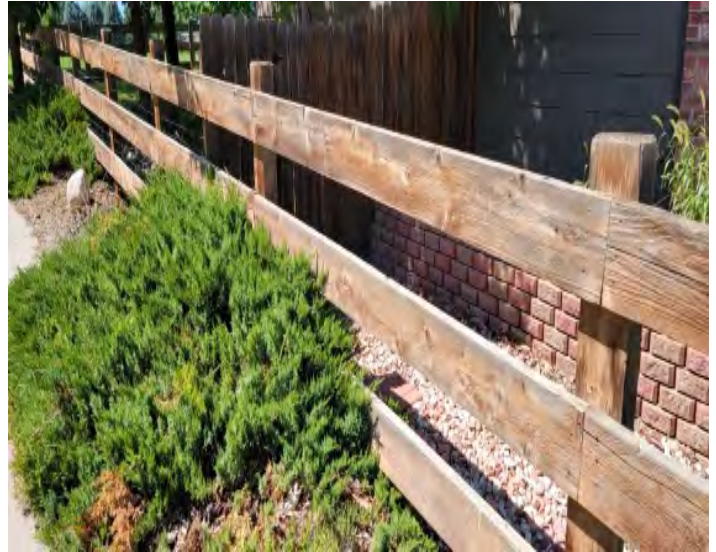
Comp #: 209 Wood Fencing/Pavilion - Restain

- In this climate, we recommend staining wood fences every 3 - 4 years to maintain appearance and protect wood surfaces from exposure to elements that will cause deterioration.

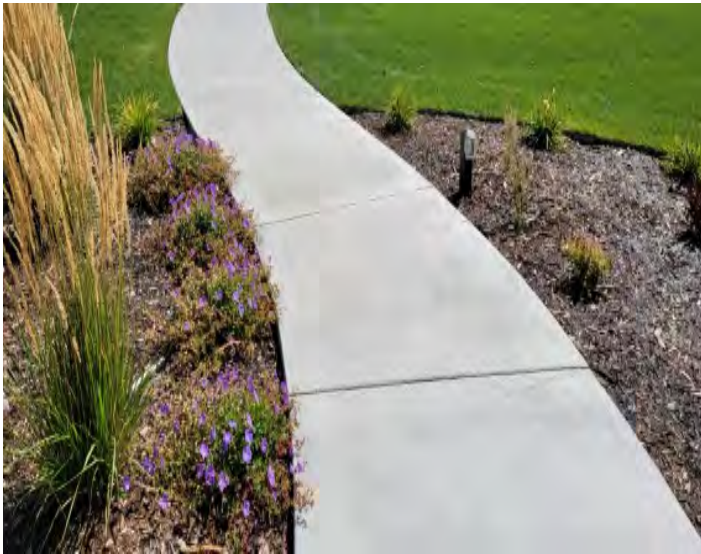
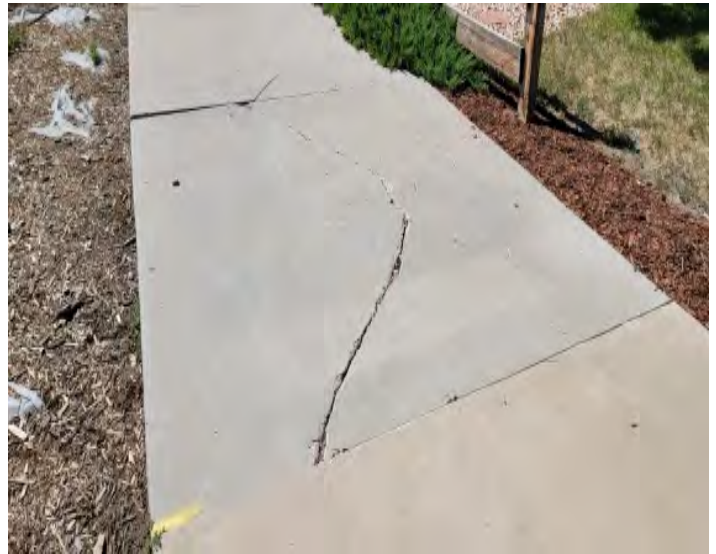
Comp #: 601 Concrete Surfaces - Repair

- It is unlikely all areas will fail and need to be replaced at the same time.
- Therefore, we set an allowance of 10% of the total area measured (1735 GSF) to be repaired every 4 years.
- As the property continues to age, it is possible the percentage or frequency of repairs will need to be adjusted in future Reserve Study updates.

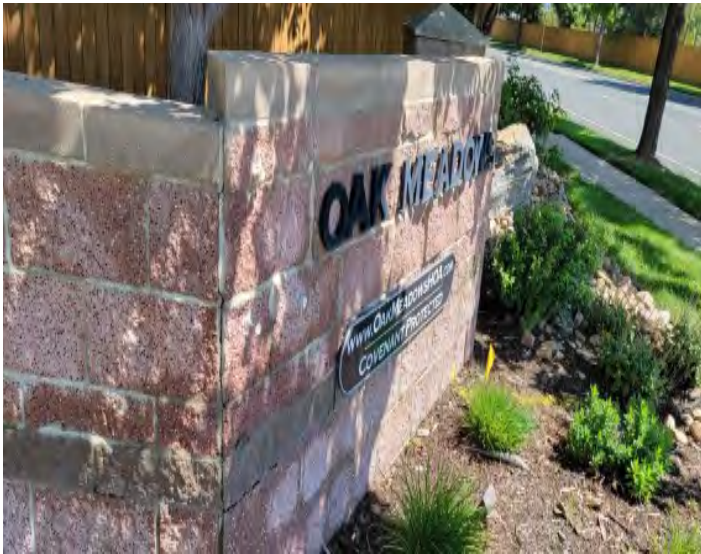
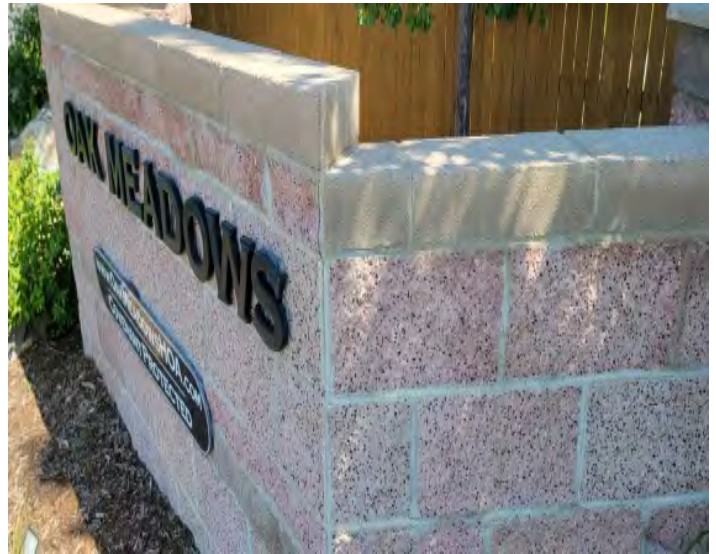
Comp #: 801      Monuments - Rebuild

- While the materials used should have an indefinite life expectancy, we recommend planning on renovating monument every 25 - 30 years to maintain current trends and an appropriate appearance.
- Remaining life is based on observed conditions and approximately age of all monuments.

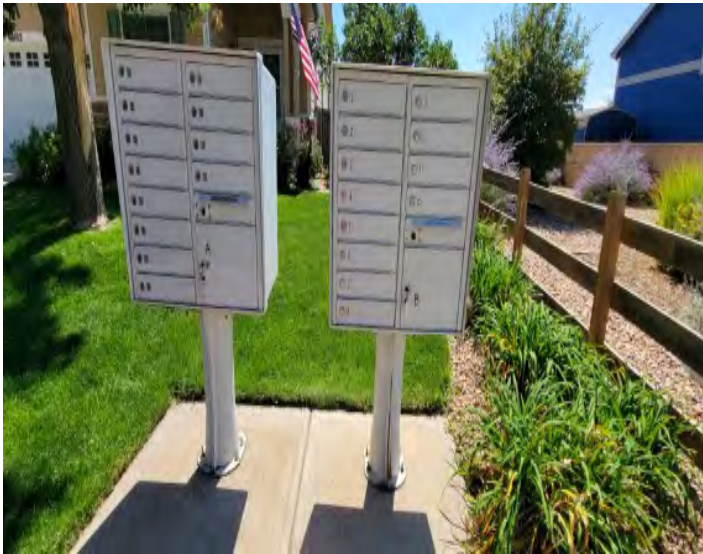
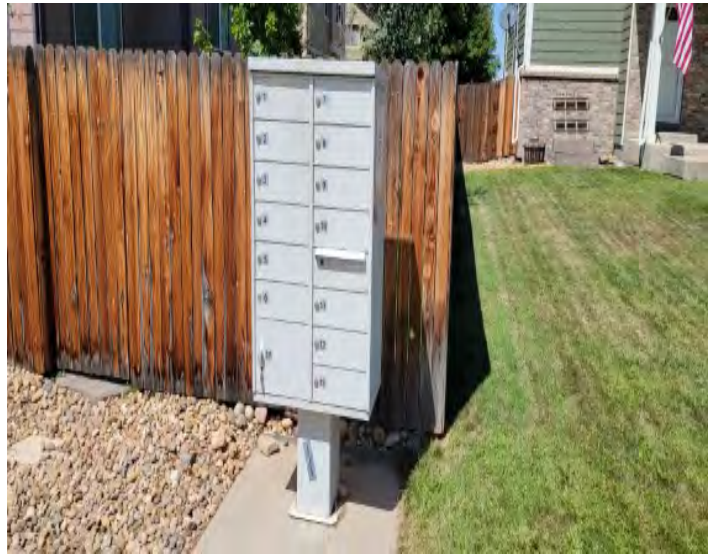
Comp #: 803 Mailboxes - Replace (2000)

- This line item is for the original mailboxes that were installed when construction of the community began.
- Per Postal regulations effective 2012, "all customers are responsible for repairs and replacement of keys, locks, or the boxes/cluster units themselves".
- Based on our experience, these boxes will have a life expectancy of 20 - 24 years due to location and quality.
- Remaining life is based on age and observed condition.

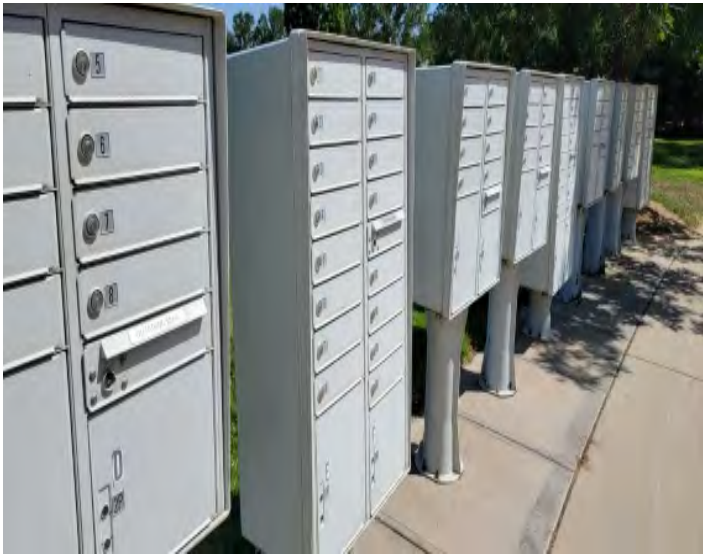
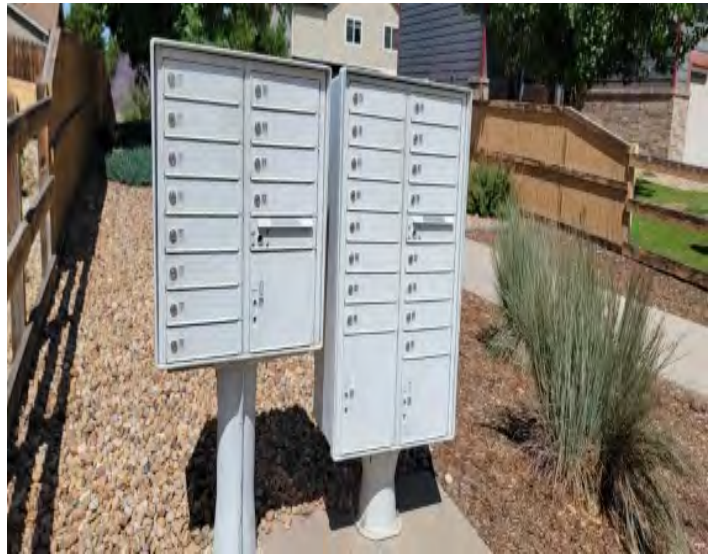
Comp #: 803 Mailboxes - Replace (2002)

- Per Postal regulations effective 2012, "all customers are responsible for repairs and replacement of keys, locks, or the boxes/cluster units themselves".
- Based on our experience, these boxes will have a life expectancy of 20 - 24 years due to location and quality.
- Remaining life is based on age and observed condition.

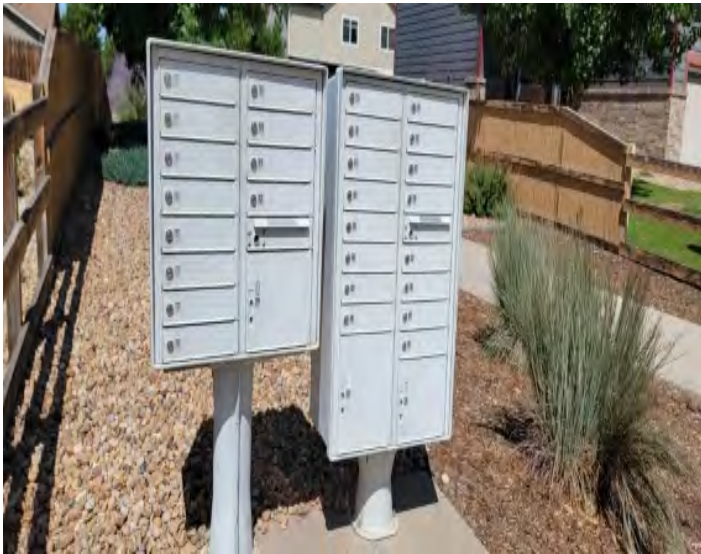
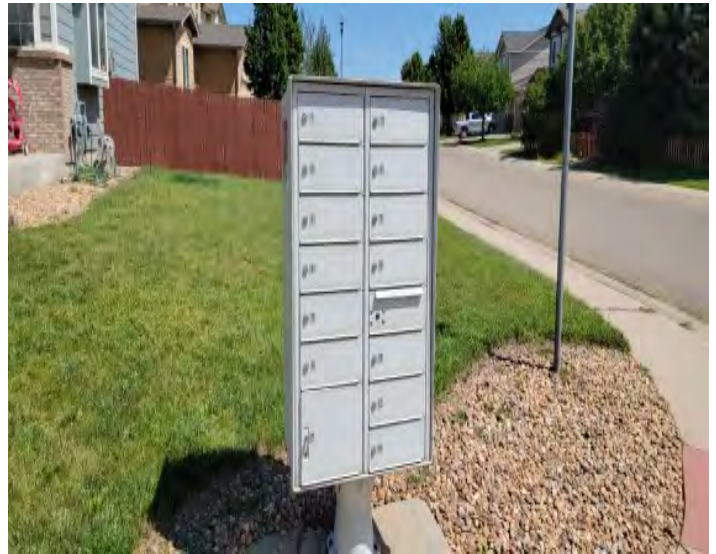
Comp #: 804 Mailboxes - Replace (2004/05)

- Per Postal regulations effective 2012, "all customers are responsible for repairs and replacement of keys, locks, or the boxes/cluster units themselves".
- Based on our experience, these boxes will have a life expectancy of 20 - 24 years due to location and quality.
- Remaining life is based on age and observed condition.

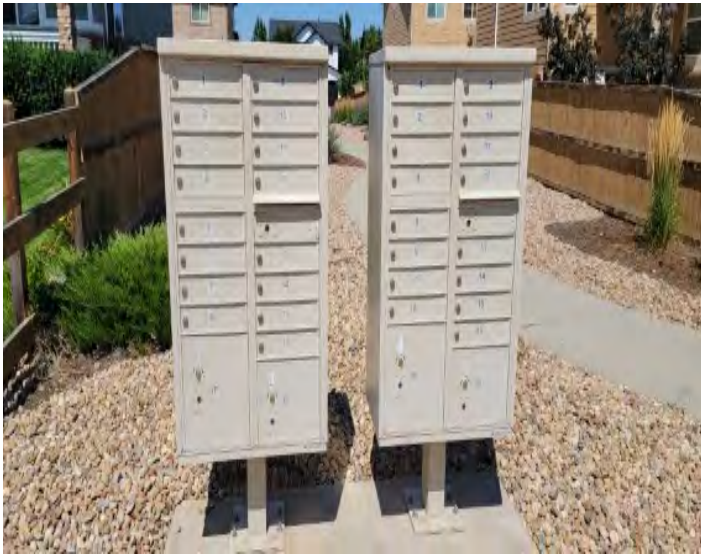
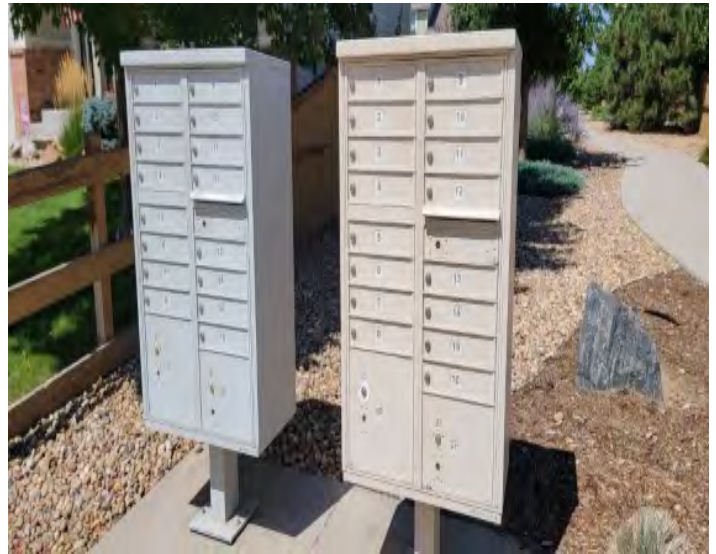
Comp #: 805 Mailboxes - Replace (2013)

- Per Postal regulations effective 2012, "all customers are responsible for repairs and replacement of keys, locks, or the boxes/cluster units themselves".
- Based on our experience, these boxes will have a life expectancy of 20 - 24 years due to location and quality.
- Remaining life is based on age and observed condition.

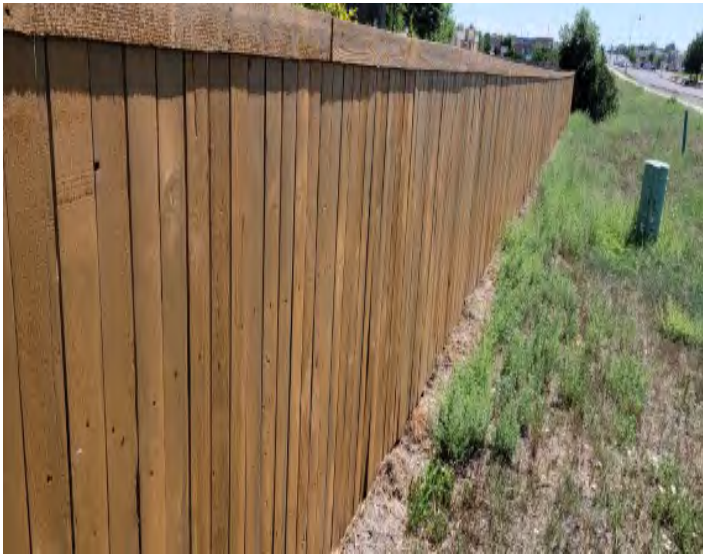
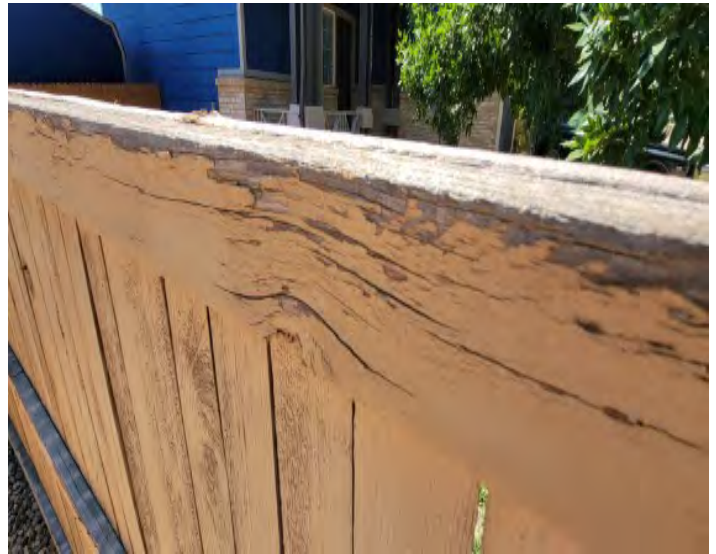
Comp #: 1001 Privacy Wood Fencing - Replace (35%)

- The replacement cycle is based on the observed quality of fence installed and the current condition.
- In our experience, fences that are stained on a periodic basis (every 3 - 4 years), have a replacement cycle of 20 - 25 years
- Due to the varying ages of the fences, this line item represents replacement of 35% of the fence (1150 LF) every 12 years.
- The remaining life is based on age of fence and observed conditions.

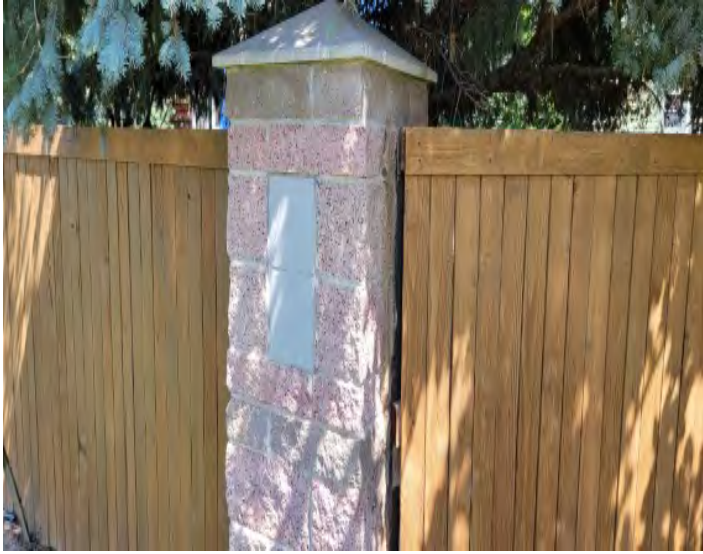
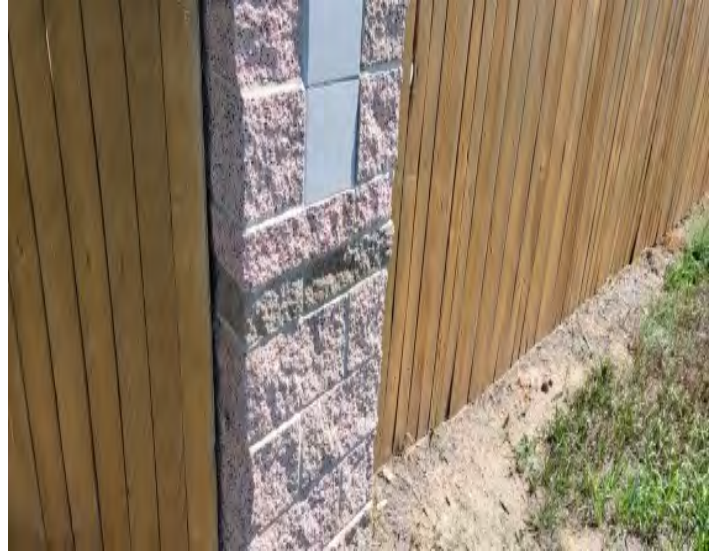
Comp #: 1005    Block Columns - Replace

- While it is unlikely that the entire column will need to be replaced, it is likely that periodic repairs may be necessary to replace loose or missing stones.
- Due to the small area, we recommend repairing these columns on an as needed basis with general operating funds.

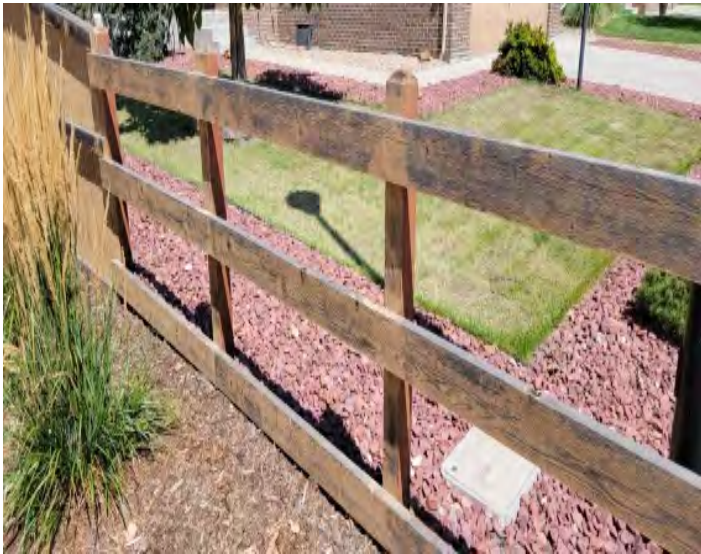
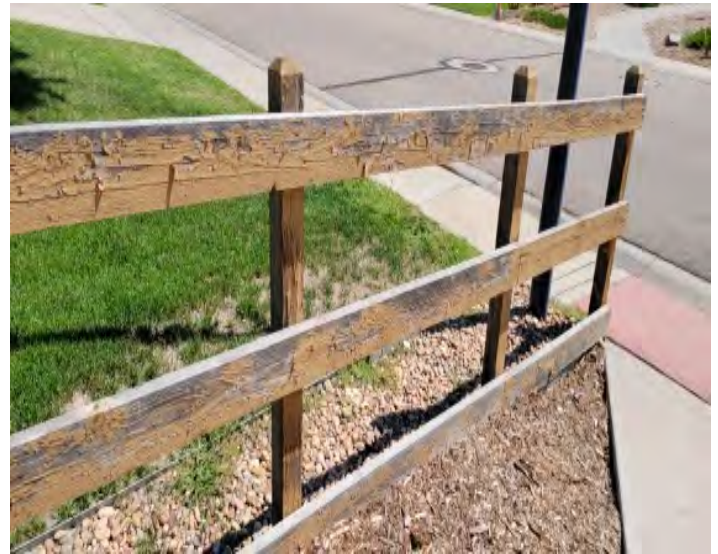
Comp #: 1009 Rail Fencing - Partial Replace

- This type of fence has an average life expectancy of 15 - 20 years, depending on level of maintenance and exposure to elements.
- Due to the varying ages of the fences and the different levels of exposure to elements, we recommend the association plan on replacing 50% of the fence every other stain cycle.
- There were no observed areas that require immediate mass replacement. A few boards and posts should be replaced as part of prep work before staining.

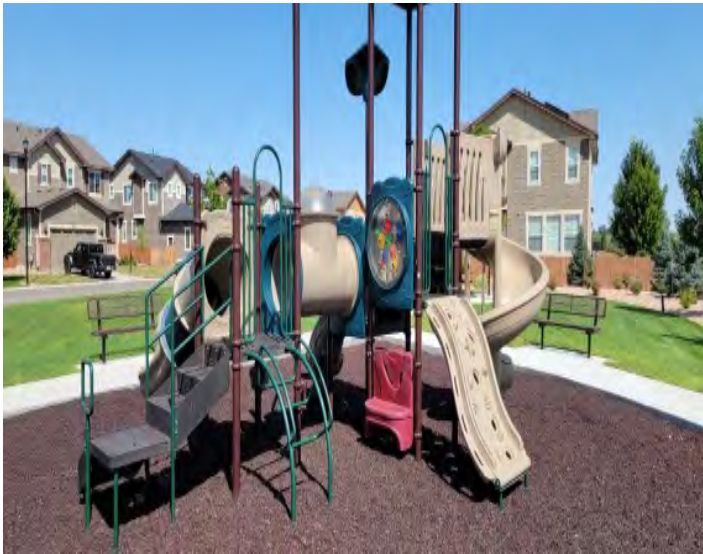
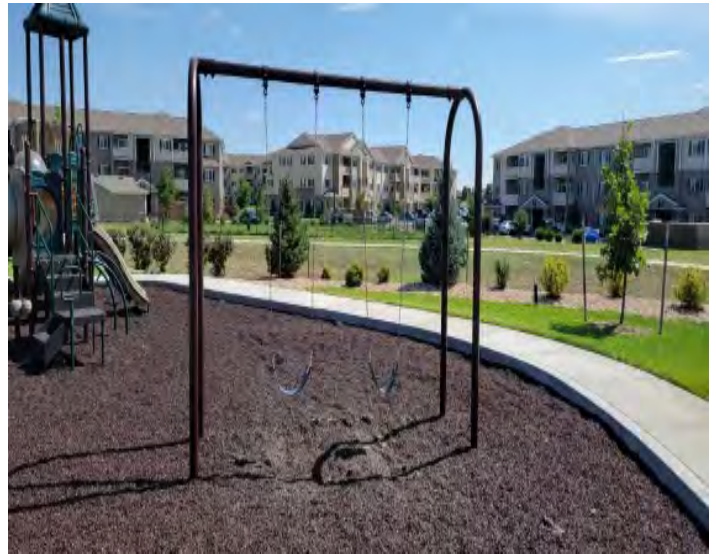
Comp #: 1301    Play Equipment - Replace

- Depending on overall level of use and care, the average life expectancy for play equipment ranges from 15 - 18 years.
- Expect high use for this facility due to the demographics of the community with the majority being young families with children.
- Estimated replacement cost is higher than amount paid in 2020 to account for labor to remove and dispose equipment during replacement

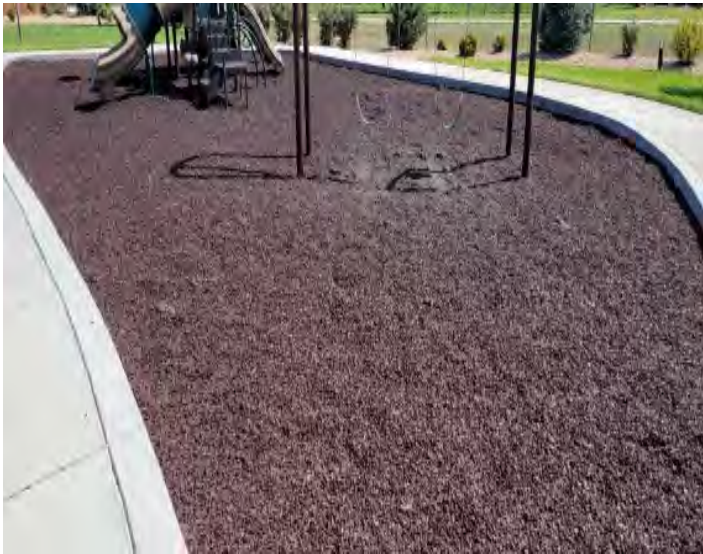
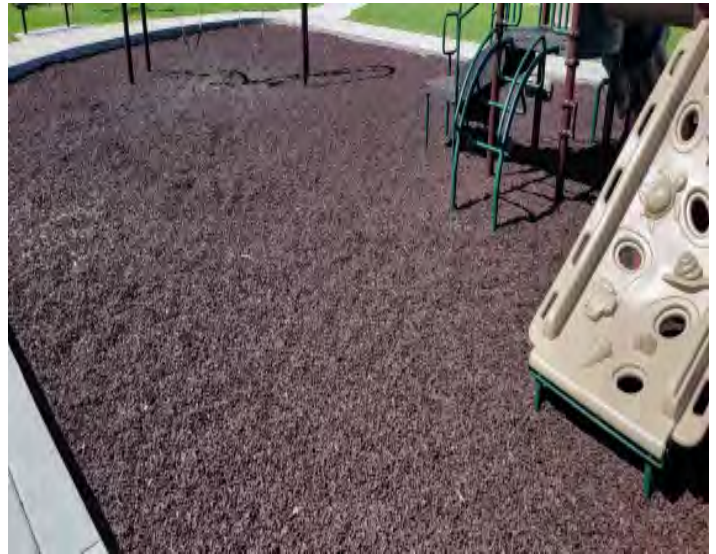
Comp #: 1303 Tot Lot Groundcover - Refill

- Depending on the level of use and care, expect to refill groundcover bed every 4 to 6 years to maintain appearance and ensure proper function as a safety component.

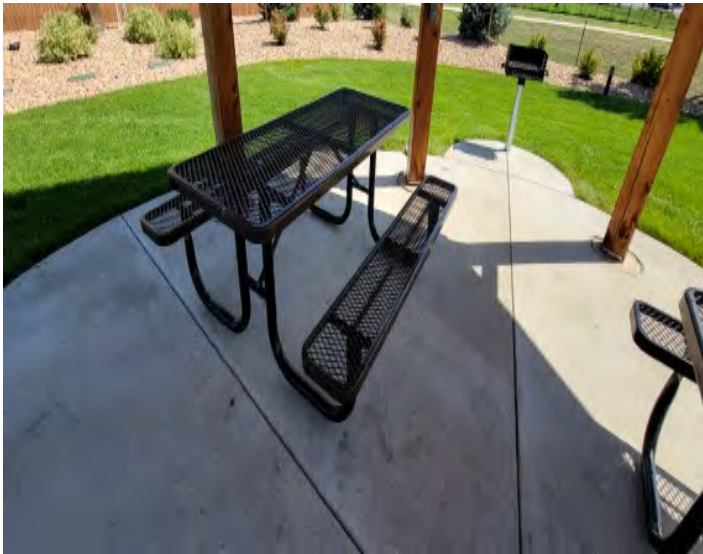
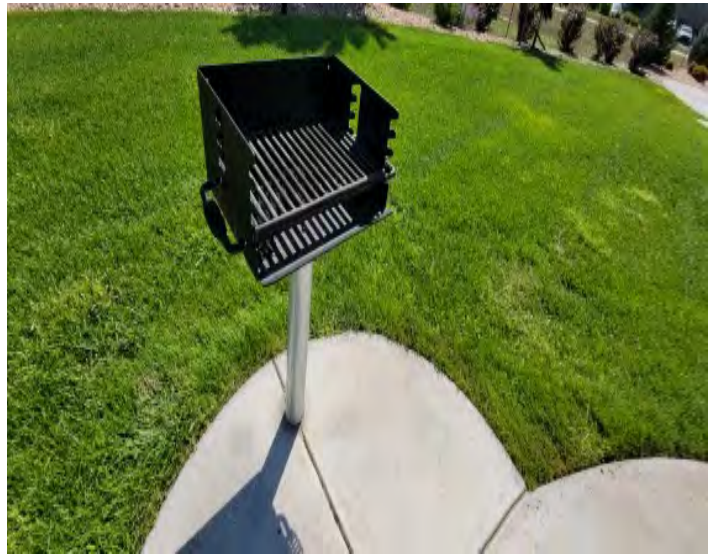
Comp #: 1305 Park Furnishings - Replace

- Expect to replace this component approximately every 10 - 12 years.
- Remaining life based on current condition.

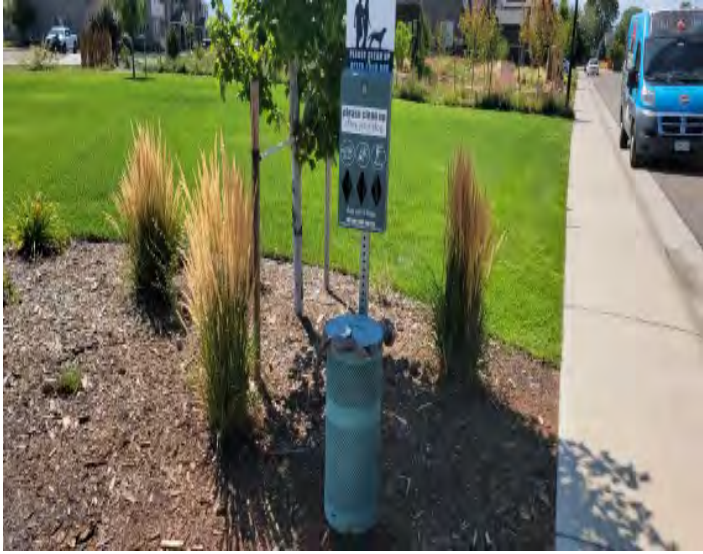
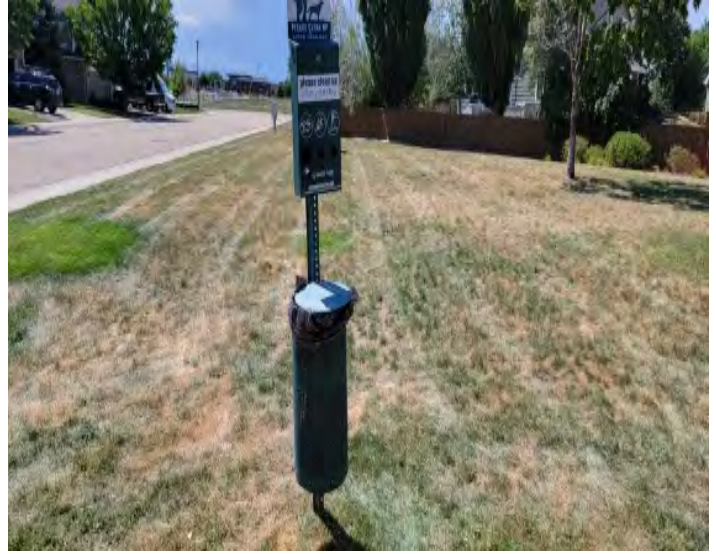
Comp #: 1311 Pet Waste Pick Up Stations - Replace

- Due to the varying ages of stations and low individual replacement cost of each station, it is an unlikely event that all will require replacement at the same time
- Therefore, we do not recommend reserving for replacement at this time.
- Maintain and replace on an as needed basis using operating funds.

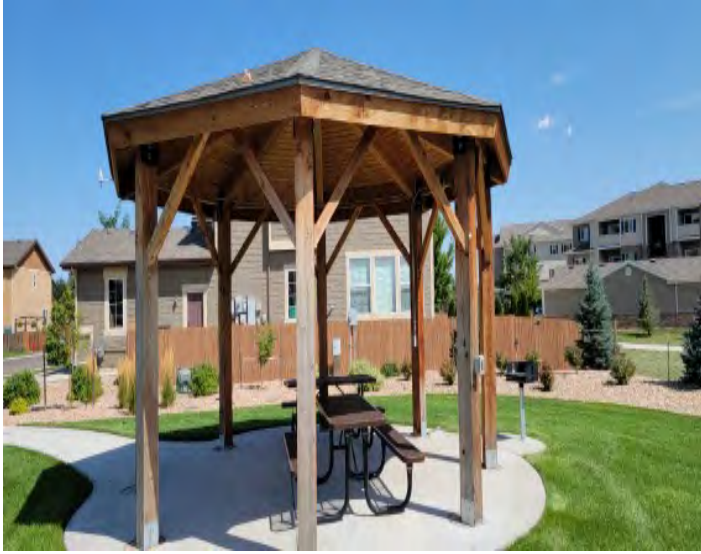
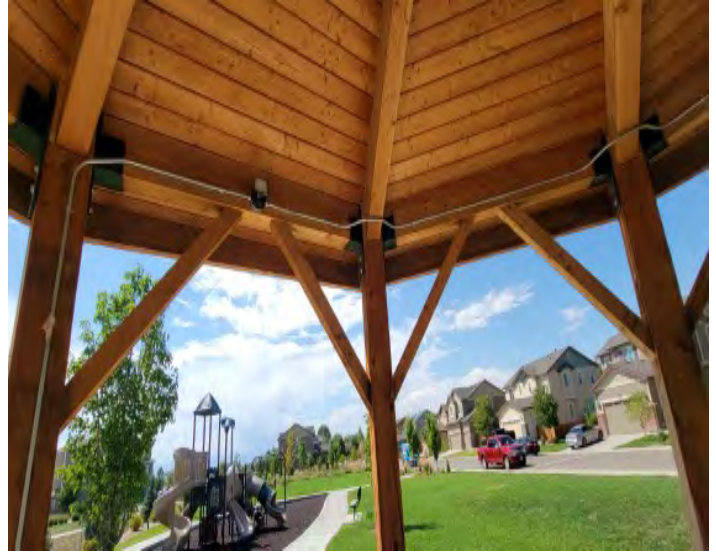
Comp #: 1314 Wood Pavilion - Replace

- In our experience, we have seen these metal structures have a replacement cycle of 25 - 35 years, depending on location and level of care.
- The remaining life is based on observed conditions and estimated age of the structure.
- Stain structure as needed with operating funds, or perform at the same time as wood fencing.

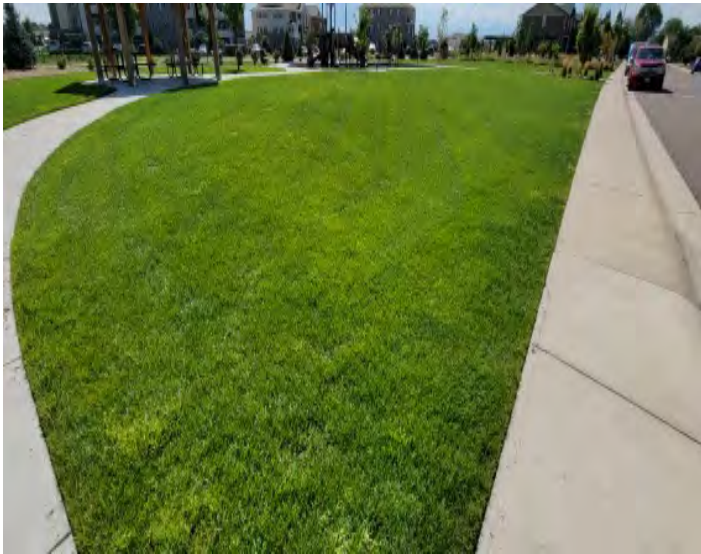
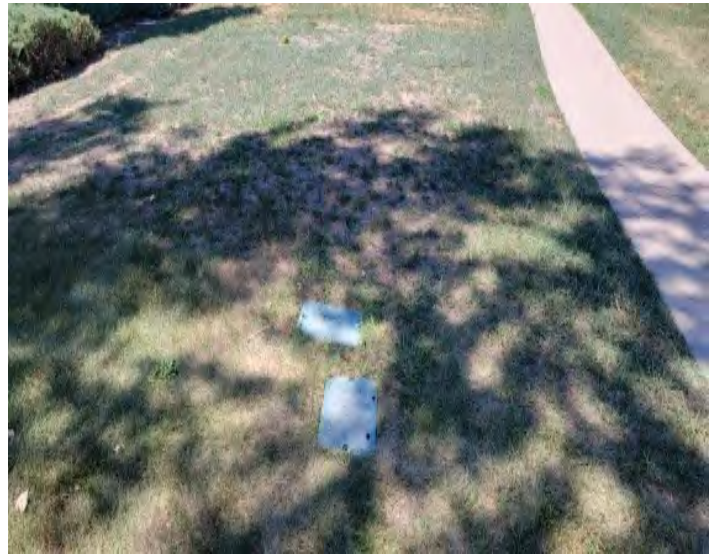
Comp #: 1701    Irrigation System - Rebuild

- This line item is for repairs and replacement that lies outside the scope of routine maintenance: bulk sprinkler head replacement, bulk valve replacement, backflow devices, rerouting lateral lines, rewiring, etc.
- In order to ensure the funds are available for major repairs, we recommend reserving funds for these projects every 4 - 5 years.
- The funding on this line item is for major repairs and is not to be interpreted as complete irrigation system replacement.

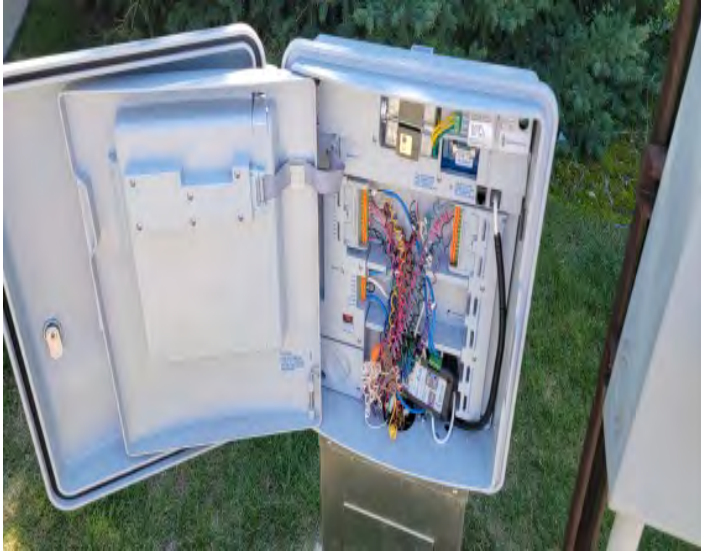
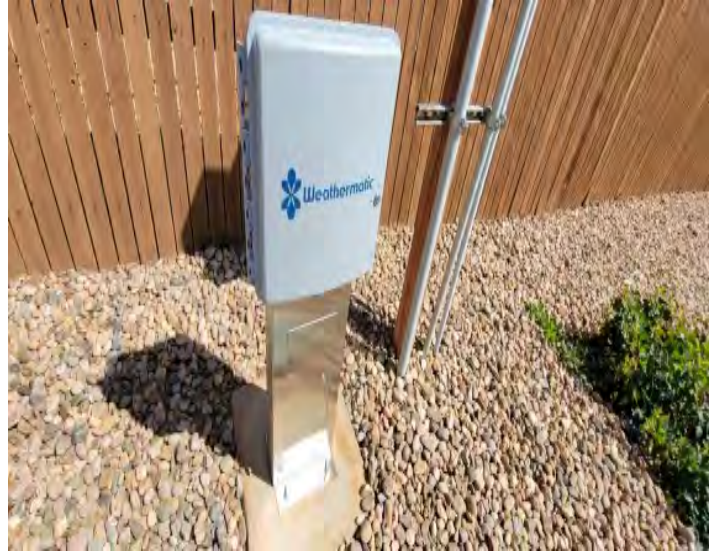
Comp #: 1703    Irrigation Controllers - Replace

- Expect to replace irrigation controllers every 10 - 12 years if properly maintained and under normal conditions.
- Funding is for replacement with a similar controller.
- Smart controllers allow the association to monitor the system remotely and improve efficiency.

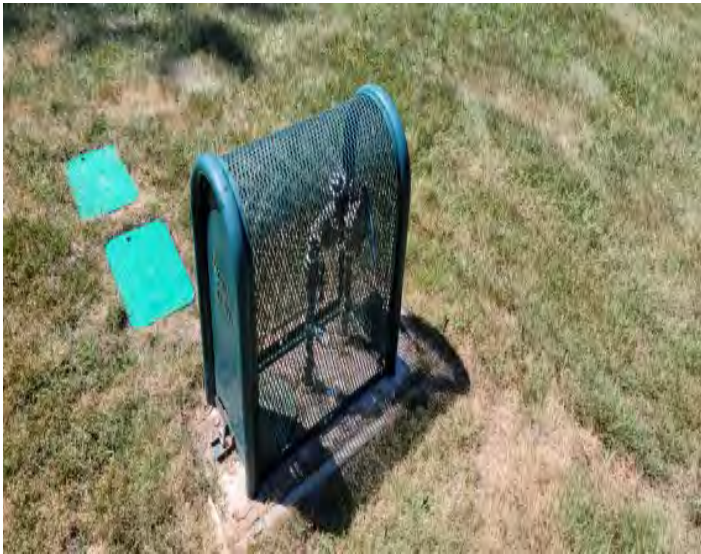
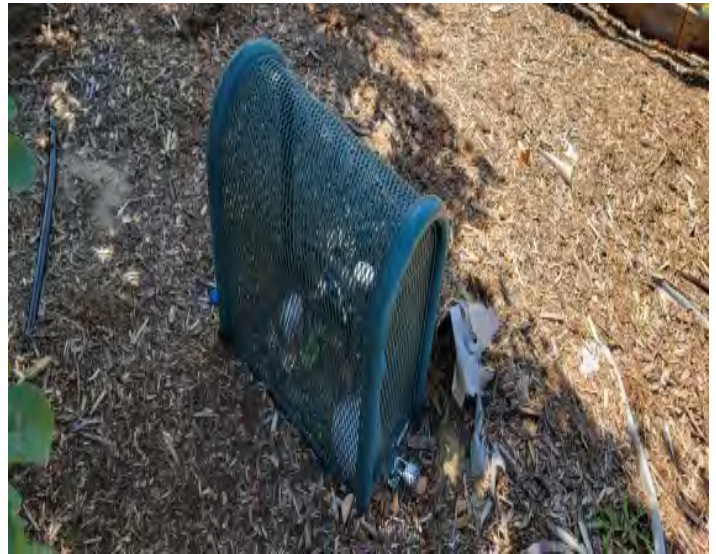
Comp #: 1706 Backflow Devices - Replace

- Devices are enclosed in a protective enclosure to prevent theft. No reported problems with any of the devices.
- Due to the ability to rebuild and replace these devices for a relatively low cost and the fact that failure of the device is unpredictable, we do not recommend reserving for replacement.
- Repair and/or replace these devices/enclosures on an as needed basis using operating funds, or include as part of major irrigation repairs (See component #1701)

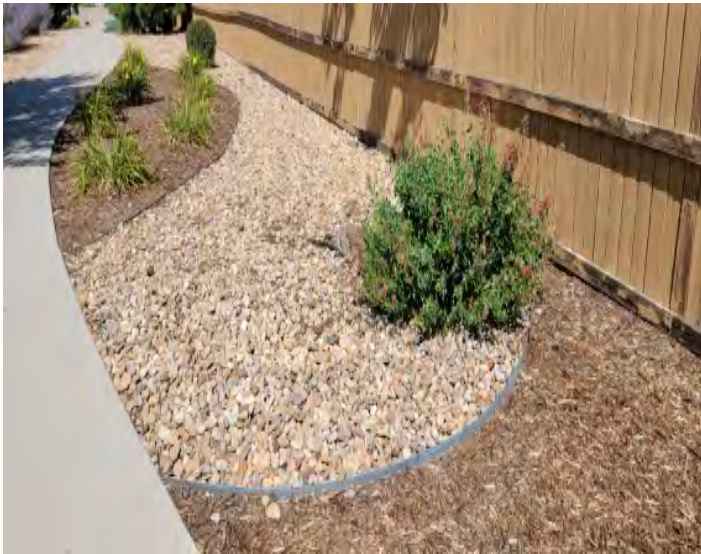
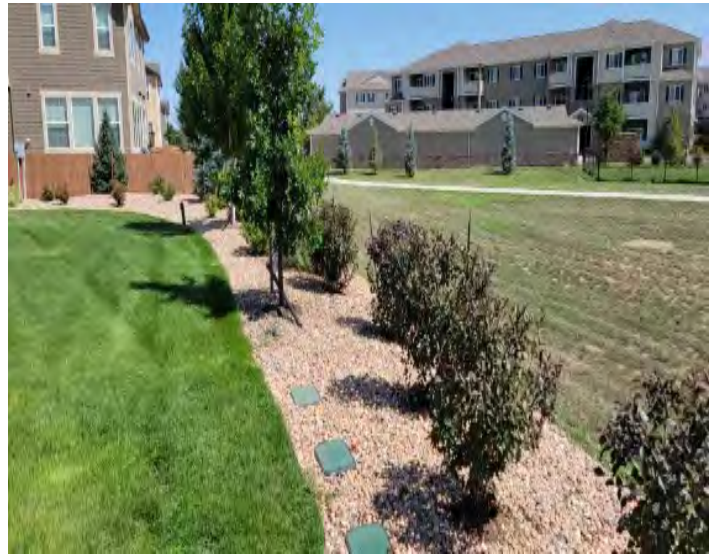
Comp #: 1801 Groundcover - Replenish

- Typically, associations will establish a line item in the operating budget to handle annual replacement of shrubs, plants, grass areas, etc.
- Therefore, separate Reserve funding is not necessary as long as funding has been established in a separate budget.
- If the association prefers to include a funding allowance for groundcover replenishment, then we would need to know how much and how often the current board of directors would prefer to set aside since this would be considered a discretionary expense.

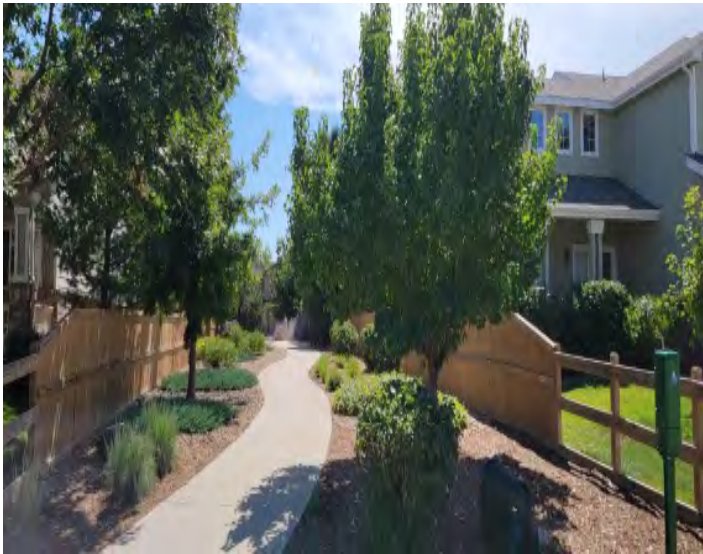
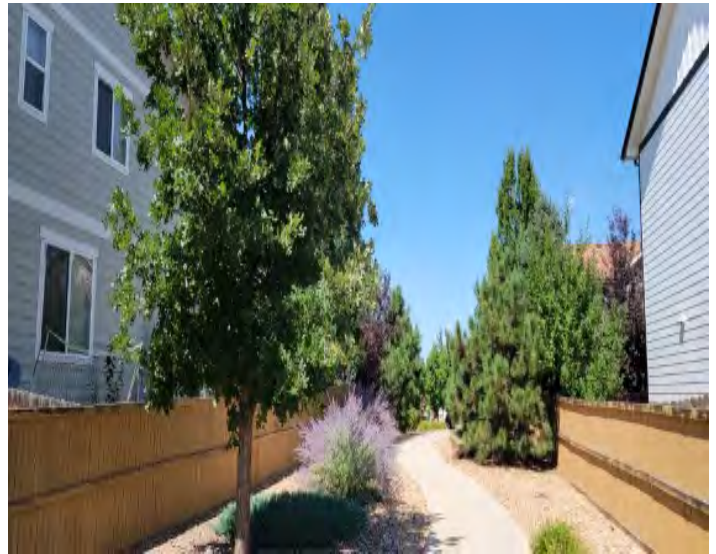
Comp #: 1804 Tree - Replacement/Major Maintenance

- It is very difficult to predict a replacement cycle for trees as there are several factors that will contribute to a tree dying.
- Factors such as disease, infestation of insects, heavy snow storms, etc. can all attribute to eventual tree replacement.
- Since it is difficult to predict when the replacement will be necessary, Reserve funding is typically not a factor.
- However, based on our recent experience, an allowance for periodic replacement has been included.
